Several instances this year of heavy rainfall seem to have led to Combined Sewage Overflows [CSO's] from Southern Water overflow pipes and other unspecified pipes onto Seaview beaches. The latest one was on August 2nd, when the brown scum on the water only seemed to disperse when the offshore winds built up on the 5th. This has caused significant local concern, particularly since the main locations of the outfalls coincide with heavily used bathing sites, two of which in particular are used in both summer and winter seasons.

Seaview Village – Storm Water / Sewage Outfalls.

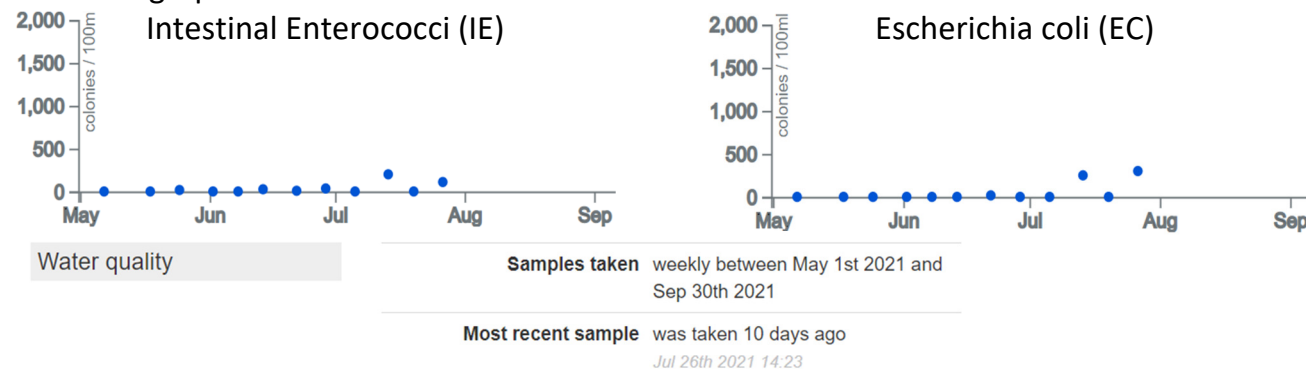
The 2021 graph shows:

Results for 2021 are generally good, save for sewage contamination found in July. As of August 5th the same webpage reports that the supposed weekly samples have conveniently not been taken for 10 days! [see screengrabs]

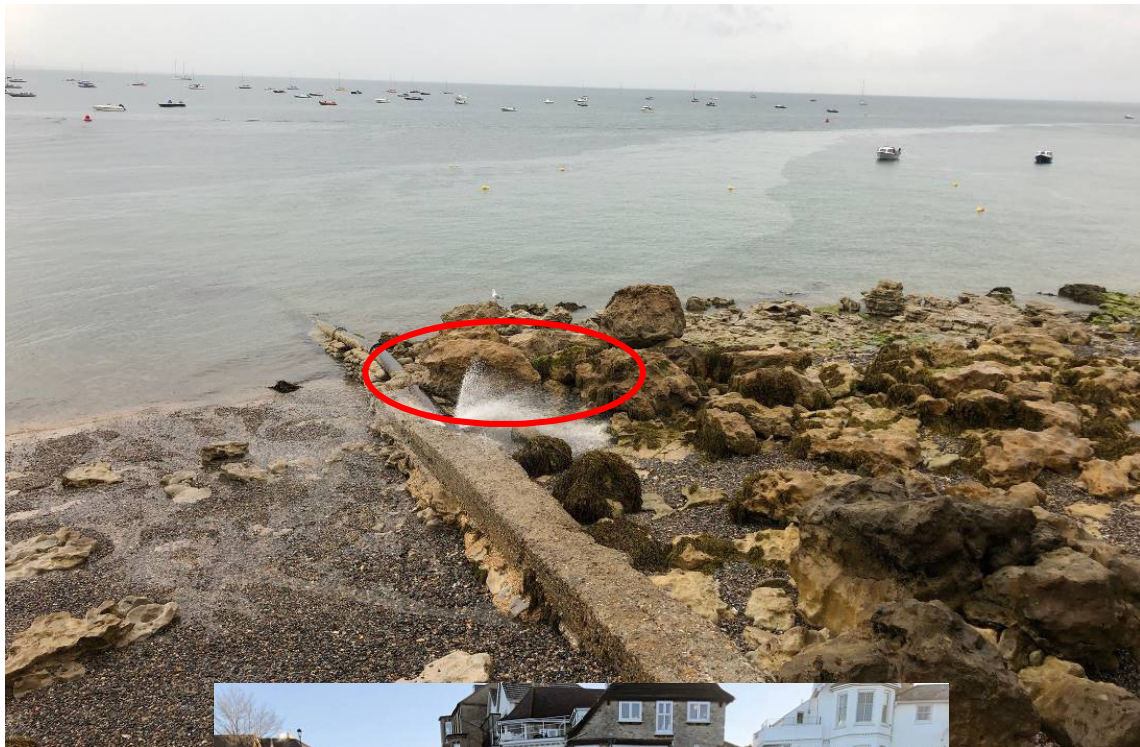
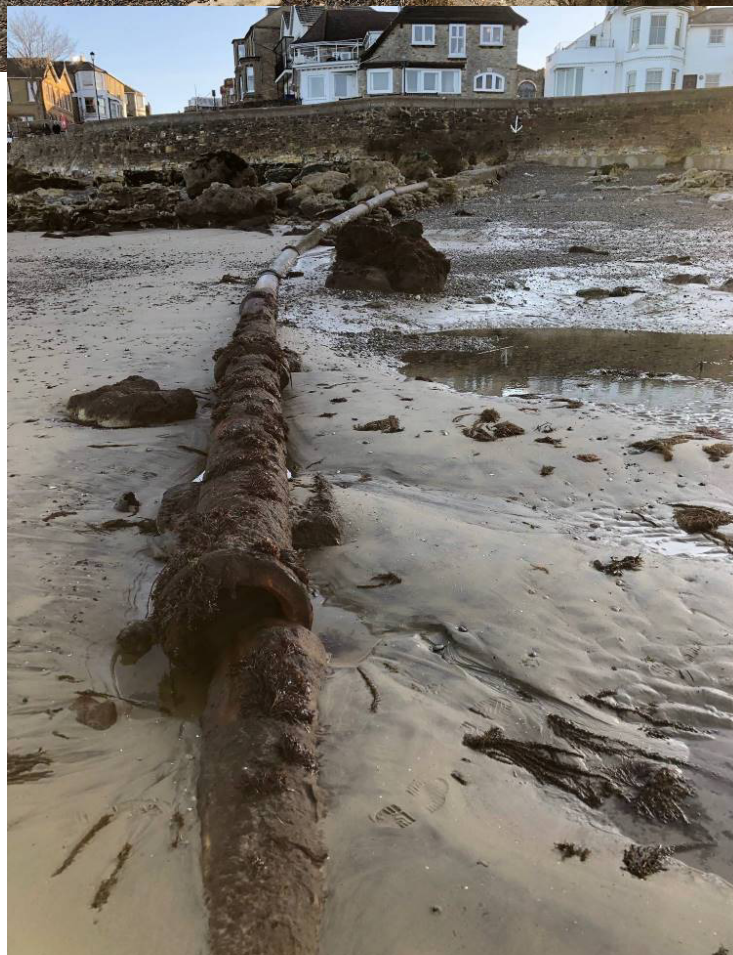
1. Bottom of the High Street opposite 'Portview'.

Images taken after heavy rain on 12/07/2021 showing that the pipe is both fractured & partially blocked lower down and is spewing out under great pressure from several fractures. Resulting in the visible oily pollution slick being carried away to the East on a falling tide.

In telephone conversations with Southern Water at the time, We were told that it was not their pipe, but the outfall is clearly marked in red on the Southern Water plan at Appendix 2.

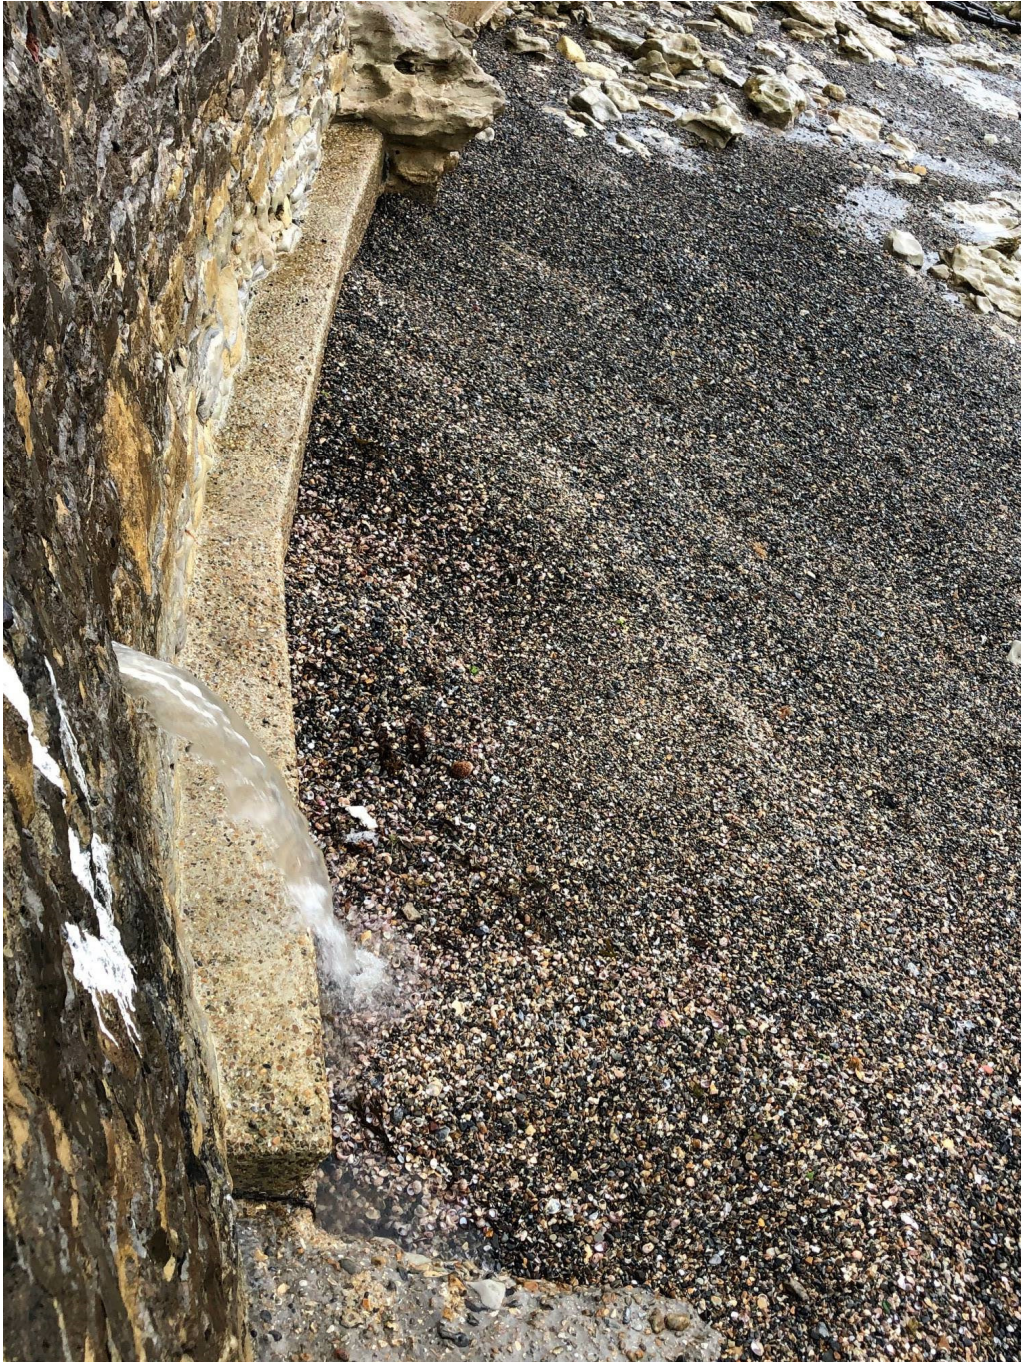
2. Bottom of the High Street c50m East of above.

Image taken after heavy rain on 12/07/2021

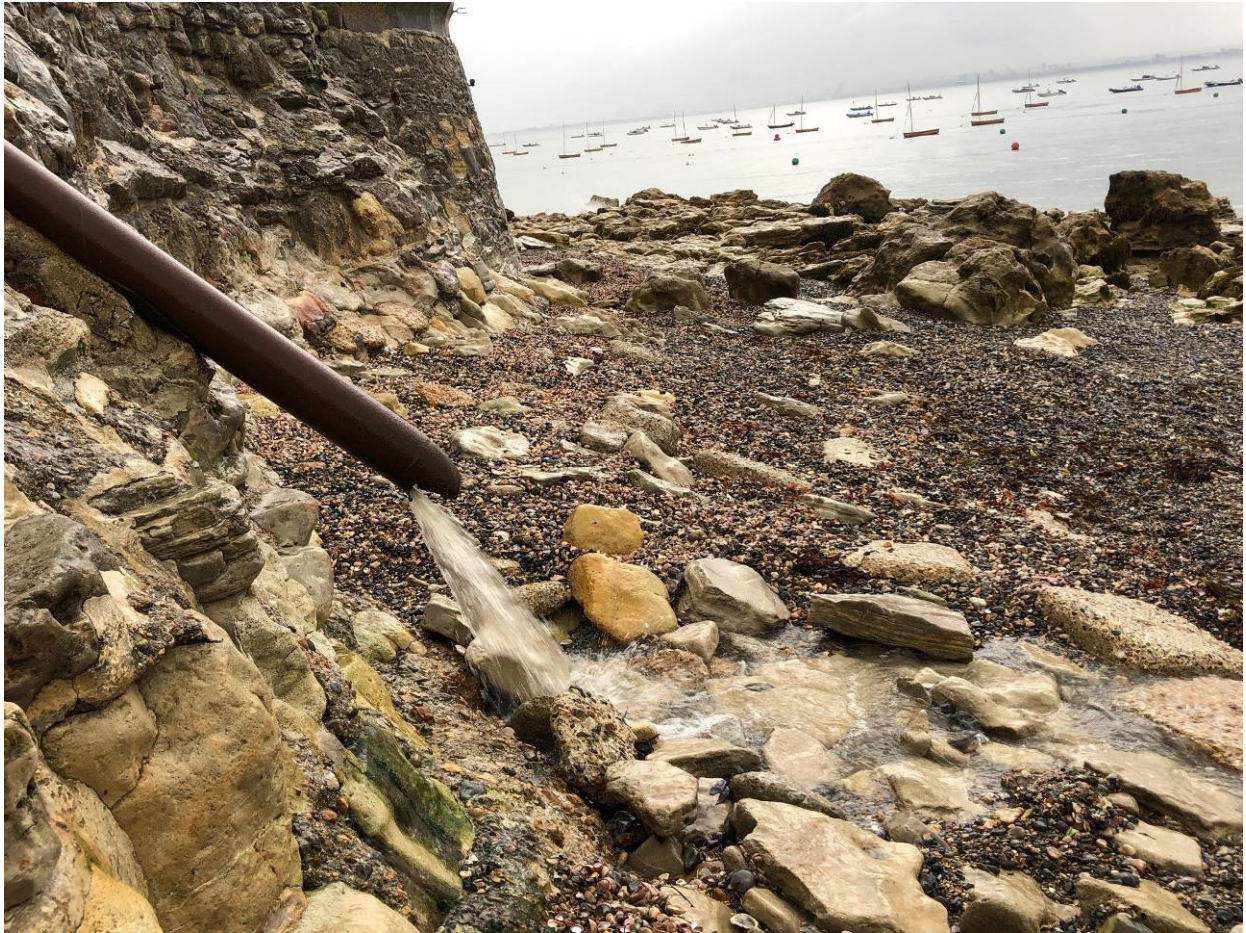
3. Bottom of the High Street opposite 'Starboard House'

Image taken after heavy rain on 12/07/2021. There was deep erosion of the beach that indicated a large volume of water and an oily pollution slick being carried away to the East on a falling tide.

The water samples taken by Southern Water in Seagrove Bay in mid-July, so immediately after this event, showed elevated levels of both Intestinal Enterococci (IE) and Escherichia coli (EC). No action was taken to alert the village to this.

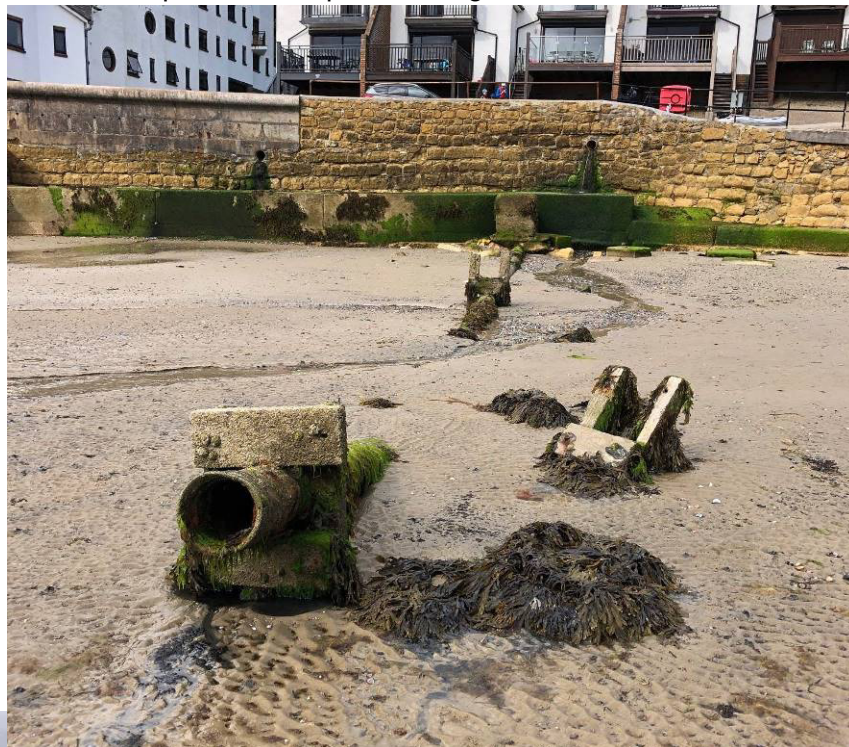
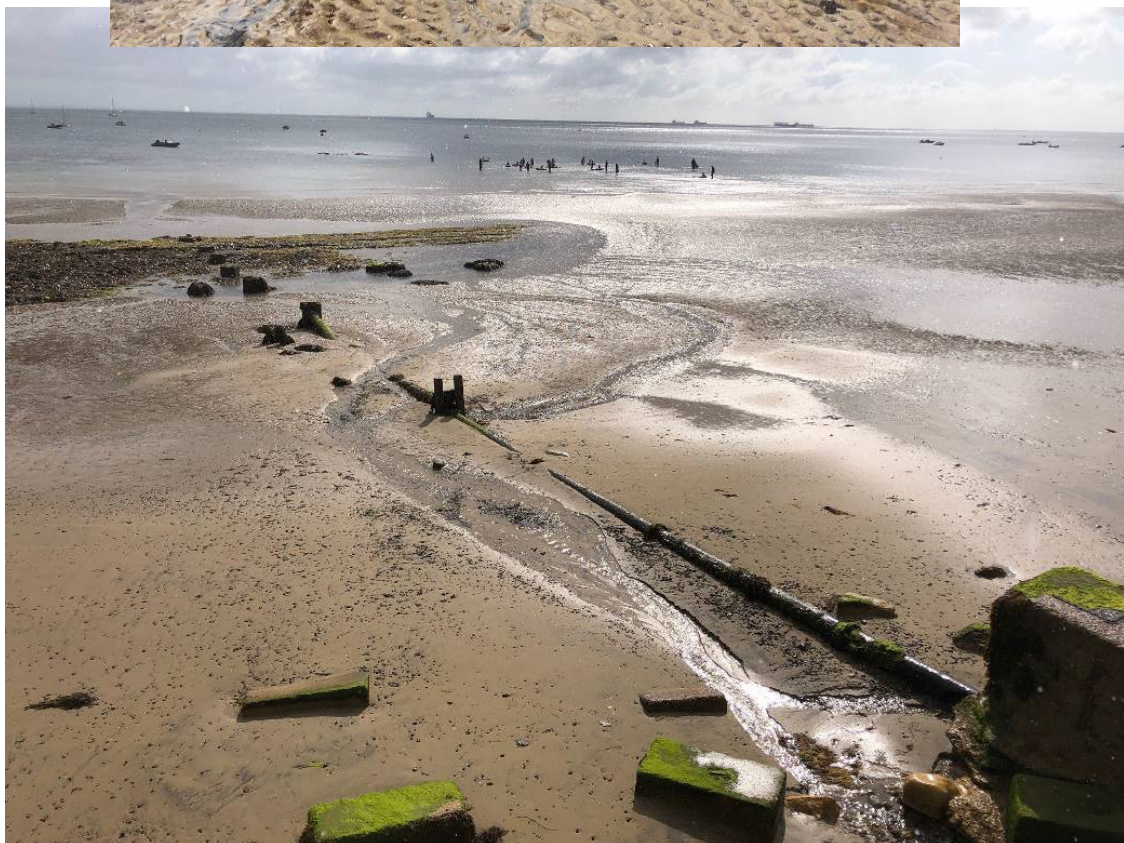
4. Seagrove / Sandy Cove. Bottom of the slipway on Pier Road.

Images taken on 28/07/2021 to show the fractured / blocked pipe, with water flowing out from under the seawall beside the pipe.

This is a very popular beach for families with small children, as shown playing in the shallow water in the 2nd image.

Seagrove is a small bay situated on the east coast of the Isle of Wight. Measuring less than 1km in length, the bay slopes gently, with channels and sandbanks at low tide. The beach is mainly sand. Two streams cross the beach and there is a sewage overflow just offshore at the north end that could operate in response to significant rainfall.

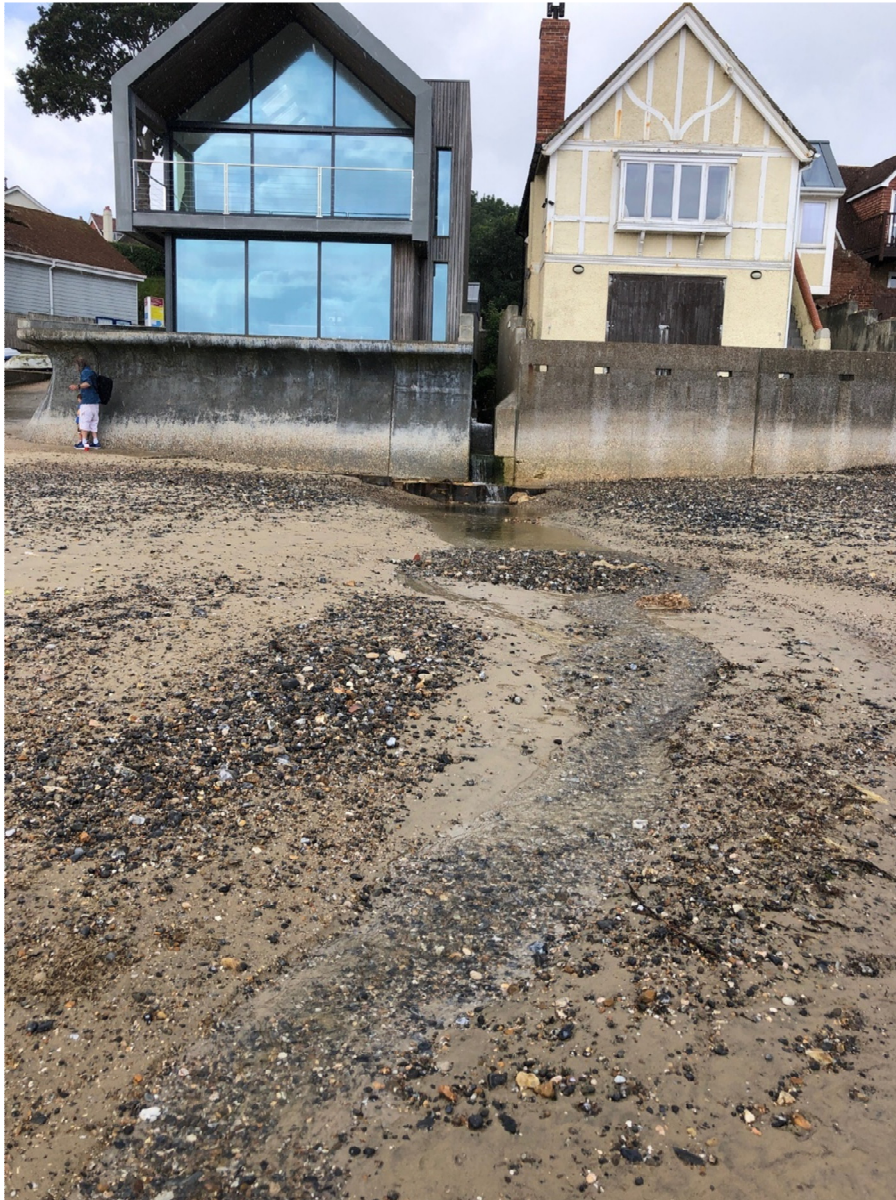
5. Seagrove Bay. Close to the slipway at the bottom of Gully Road

Image taken on 28/07/2021 to show what appears to be a natural stream / land drain that flows very fast after heavy rain, as demonstrated by the heavy beach erosion. This is a very popular place for children to play in this flowing water on the beach.

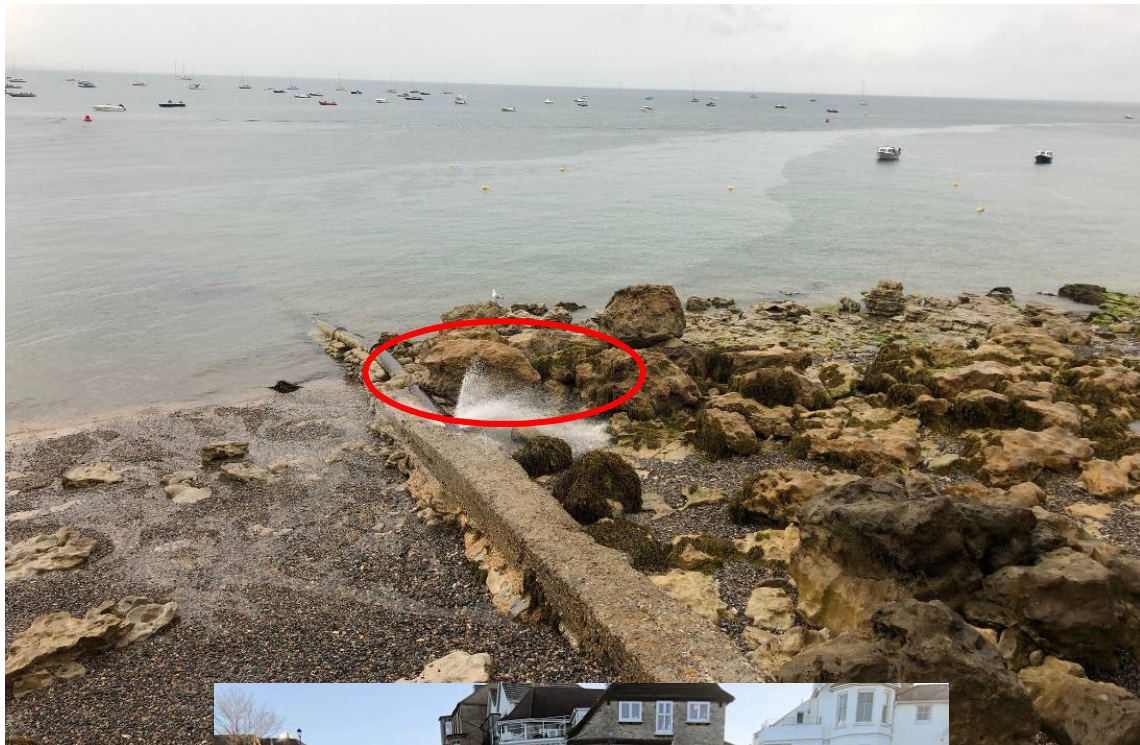
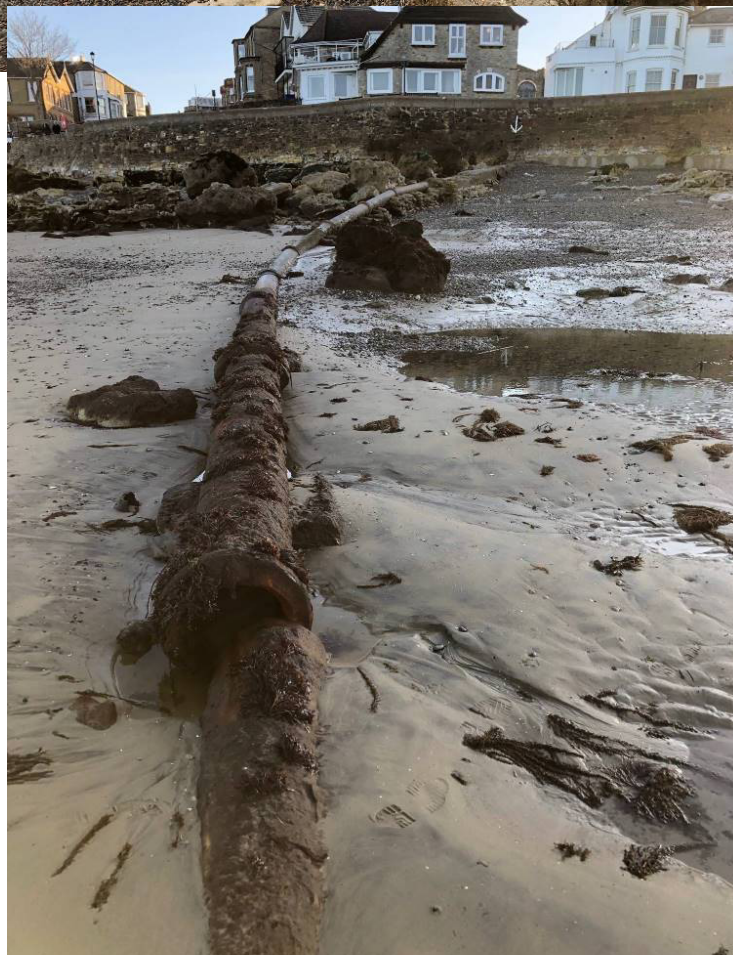
1. Bottom of the High Street opposite 'Portview'.

Images taken after heavy rain on 12/07/2021 showing that the pipe is both fractured & partially blocked lower down and is spewing out under great pressure from several fractures. Resulting in the visible oily pollution slick being carried away to the East on a falling tide.

In telephone conversations with Southern Water at the time, We were told that it was not their pipe, but the outfall is clearly marked in red on the Southern Water plan at Appendix 2.

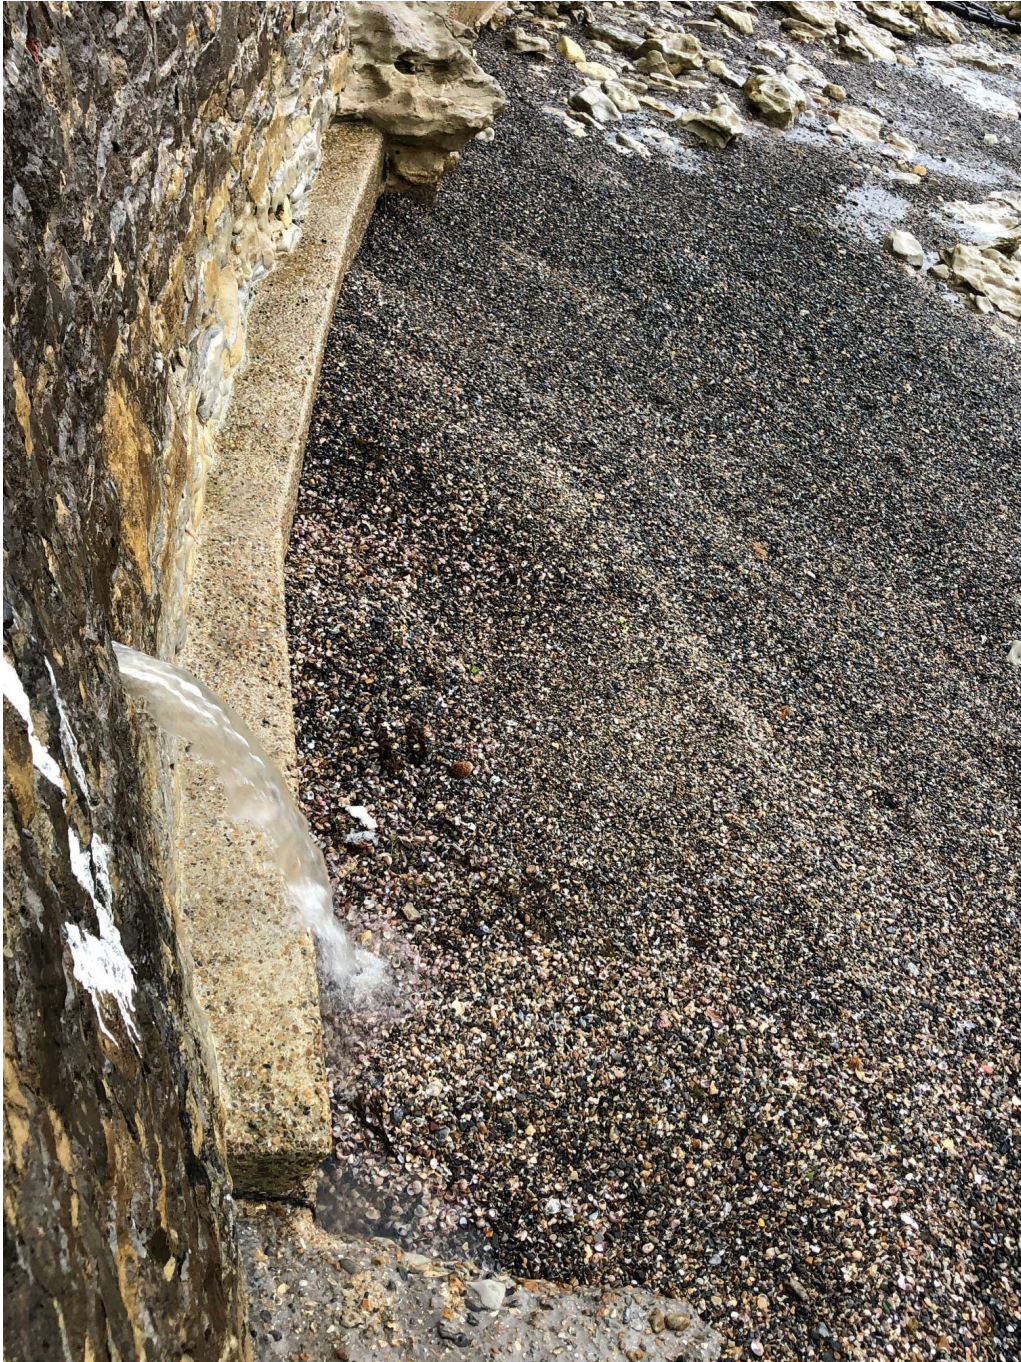
2. Bottom of the High Street c50m East of above.

Image taken after heavy rain on 12/07/2021

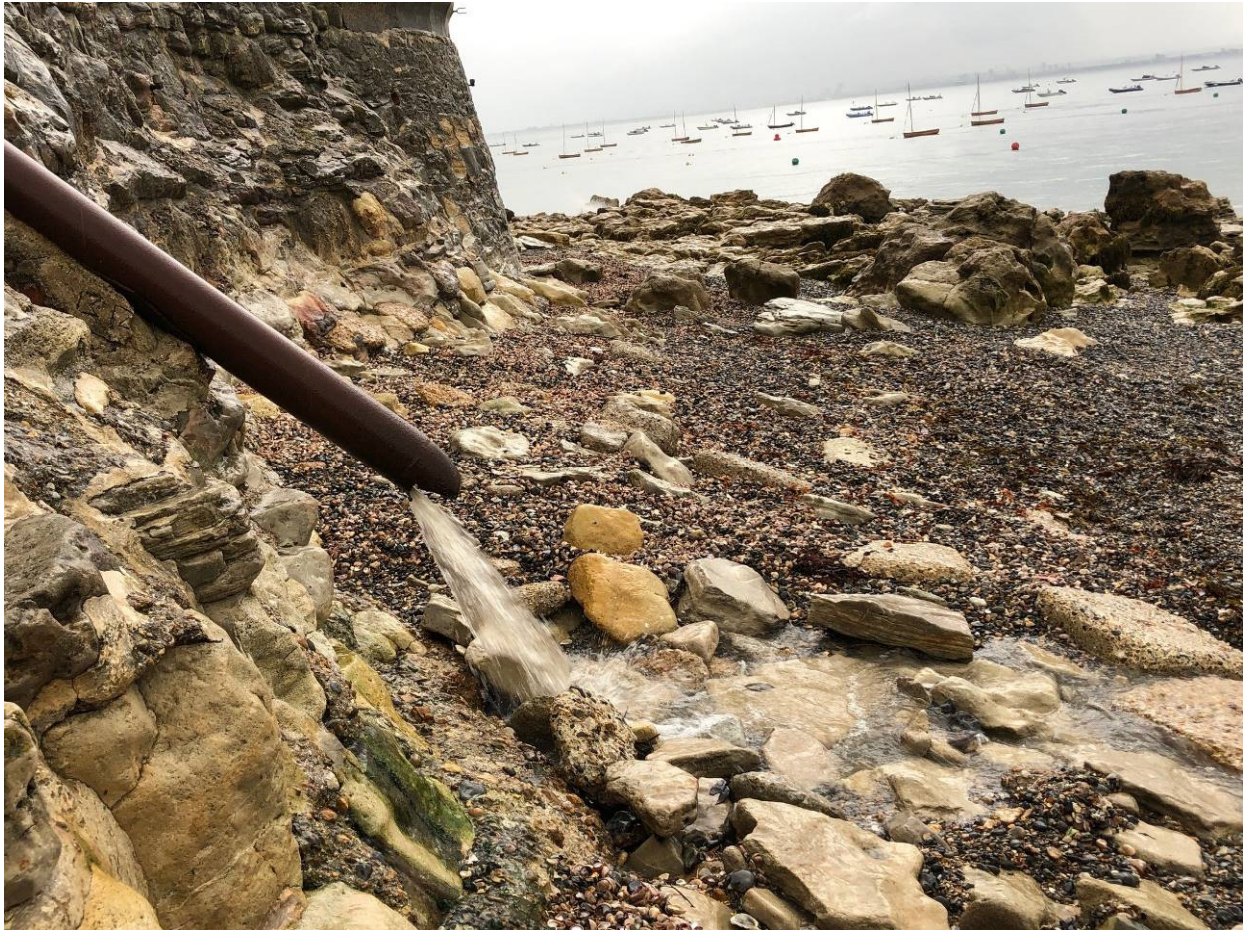
3. Bottom of the High Street opposite 'Starboard House'

Image taken after heavy rain on 12/07/2021. There was deep erosion of the beach that indicated a large volume of water and an oily pollution slick being carried away to the East on a falling tide.

The water samples taken by Southern Water in Seagrove Bay in mid-July, so immediately after this event, showed elevated levels of both Intestinal Enterococci (IE) and Escherichia coli (EC). No action was taken to alert the village to this.

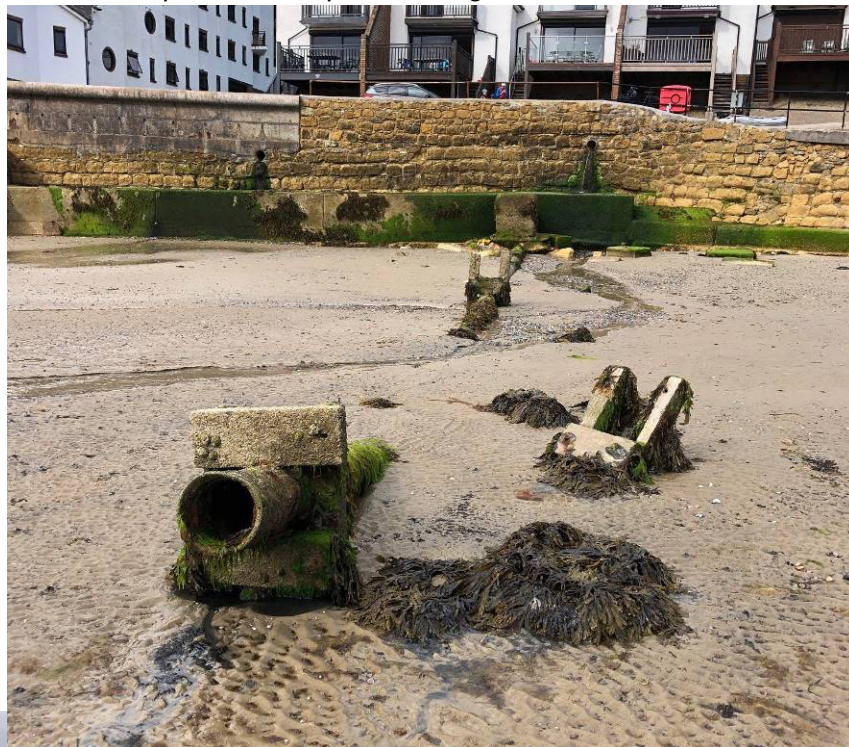
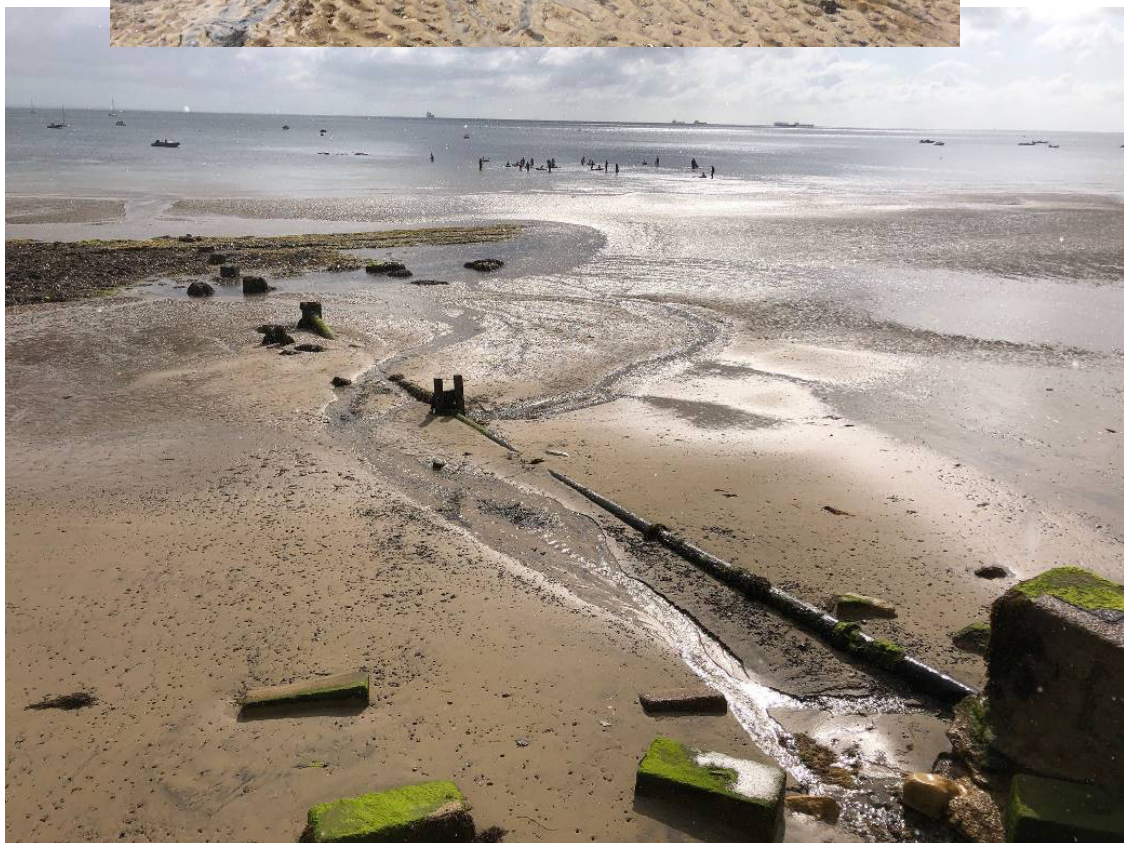
4. Seagrove / Sandy Cove. Bottom of the slipway on Pier Road.

Images taken on 28/07/2021 to show the fractured / blocked pipe, with water flowing out from under the seawall beside the pipe.

This is a very popular beach for families with small children, as shown playing in the shallow water in the 2nd image.

Seagrove is a small bay situated on the east coast of the Isle of Wight. Measuring less than 1km in length, the bay slopes gently, with channels and sandbanks at low tide. The beach is mainly sand. Two streams cross the beach and there is a sewage overflow just offshore at the north end that could operate in response to significant rainfall.

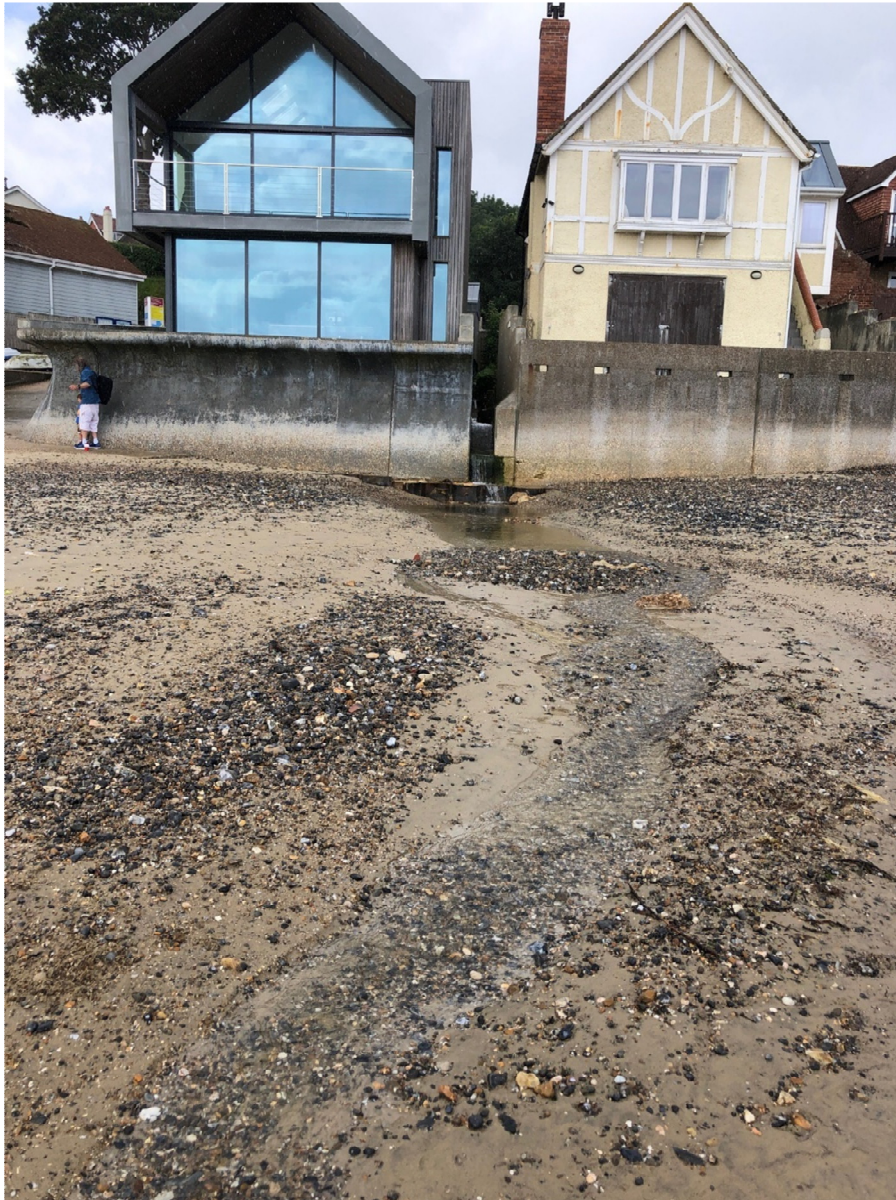
5. Seagrove Bay. Close to the slipway at the bottom of Gully Road

Image taken on 28/07/2021 to show what appears to be a natural stream / land drain that flows very fast after heavy rain, as demonstrated by the heavy beach erosion. This is a very popular place for children to play in this flowing water on the beach.
